RE: GLADSTONE CROSSING TREE SURVEY, MAPLEWOOD, MINNESOTA

ISG completed a Level 2 Tree Assessment and Inventory on May 19, 2023. The survey area consisted of 1375 Frost Avenue (parcel IDs 152922230023 and 152922230087), totaling approximately 1 acre of land, in the city of Maplewood, MN (refer to attached Figure 1 – Project Location Map). At the time of assessment, the survey area was composed of two vacant lots consisting of an empty building, parking lot, and manicured lawn.

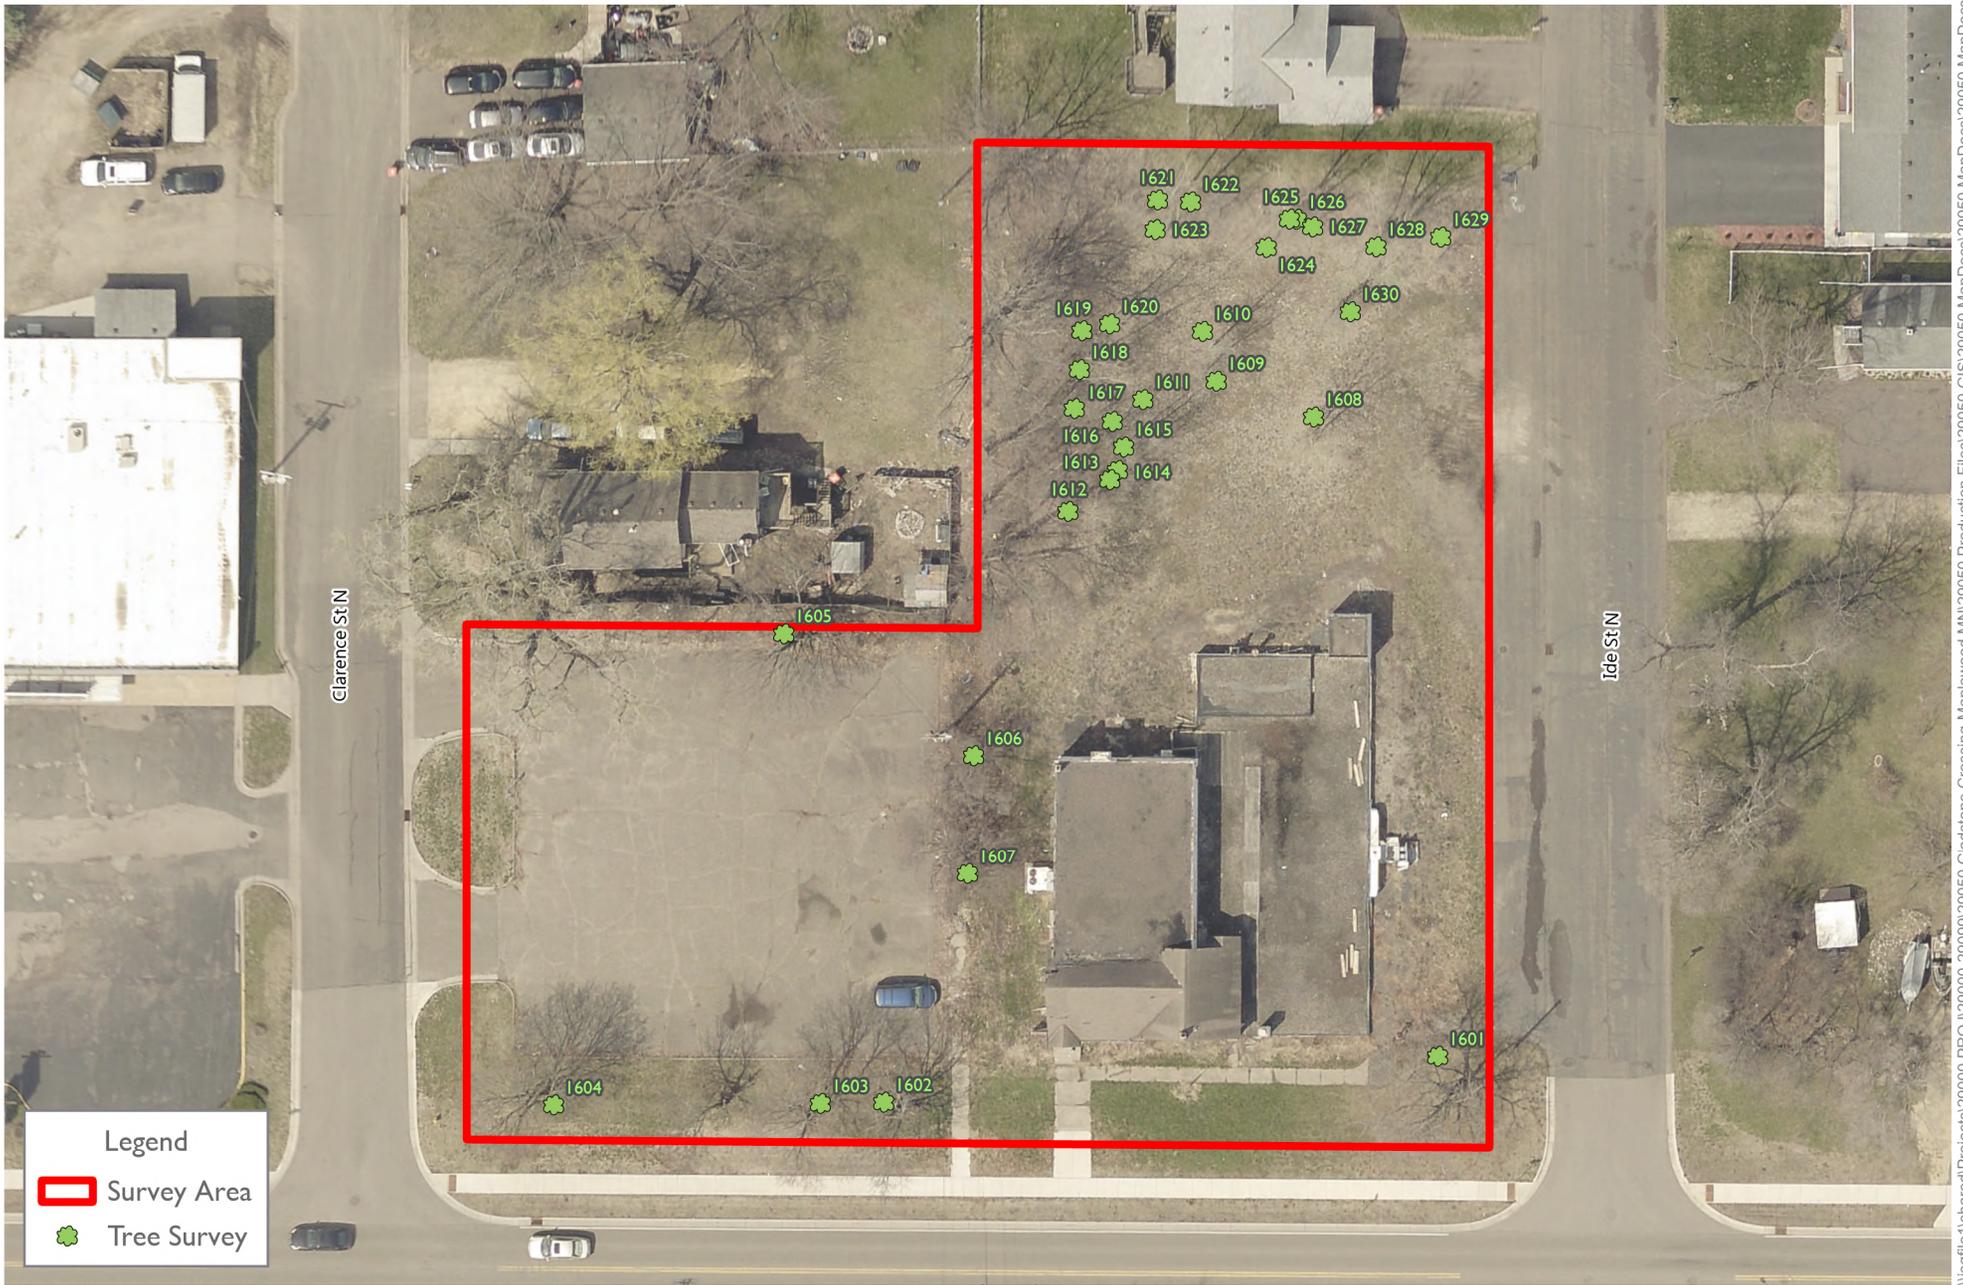
Figure 2
Tree Survey Map
Gladstone Crossing
 Maplewood, Ramsey County, Minnesota

A total of 30 significant trees were inventoried and tagged within the project boundary. Tree locations are shown on the attached tree survey maps.
